## FACILITY ASSESSMENT

**CHARLESTON FIRE DEPARTMENT  
FITNESS AND TRAINING CENTER  
502 26TH STREET**

**Prepared by:  
ZMM Architects & Engineers  
19 - October - 2021**

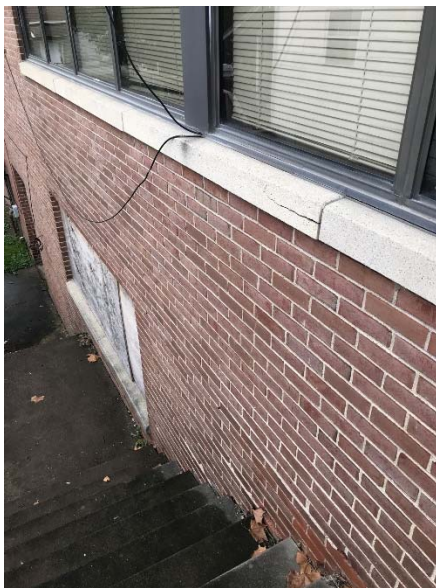
As noted above the fitness building was originally constructed as a fire station in 1954. It is single-story brick and masonry loadbearing construction with a steel frame, metal joists, a tectum roof deck, and a brick veneer. The building has a basement that is exposed at full height on the back of the facility. The left side of the building has exterior stairs that connect the upper and lower level, while the right side has a large stone retaining wall that is adjacent to the vehicular bays separating a sloping alley from the front parking area. The retaining wall is deteriorating and requires replacement. The building has flat roofs and significant sloping overhangs. Windows have been replaced on the upper floor, but the original windows remain on the lower. Nearly all lower-level windows are boarded up on exterior and are exposed on the interior. Windowsill cracking is typical throughout, and quite significant in several areas.

Damaged Windowsill

A variety of exterior defects are noticeable including damaged masonry windowsills as well as cracking, settling, and shifting in the masonry veneer. The soffits are wood with vinyl applied over the soffit to improve the appearance. Some of the fascia has been replaced, but damaged original fascia remains in some areas. These defects should be repaired. Additionally, the building still has the two large overhead doors to the previous vehicle bays. The doors should be replaced, preferably with a storefront system that would infill the existing openings to eliminate water infiltration and additional damage.

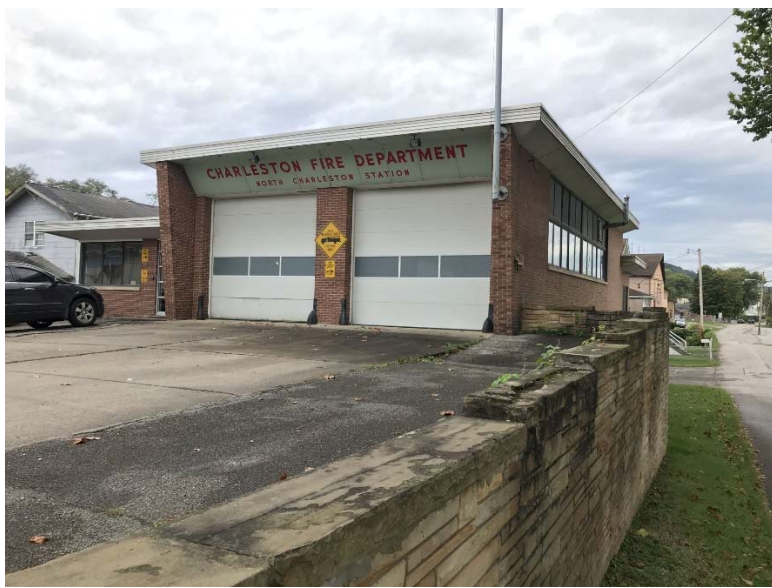
Failing Exterior Retaining Wall

The location of the facility in the floodplain makes the lower level of the facility unusable for the current purpose without significant modifications to floodproof the building. Additionally, the facility requires extensive renovations including a new roof, masonry repair, replacement of a retaining wall, toilet room reconfiguration (for accessibility), as well as new mechanical and electrical systems. ZMM anticipates that the cost for the improvements required to occupy the main level would be between \$750K-\$950K, and the facility would still be undersized for the intended use.

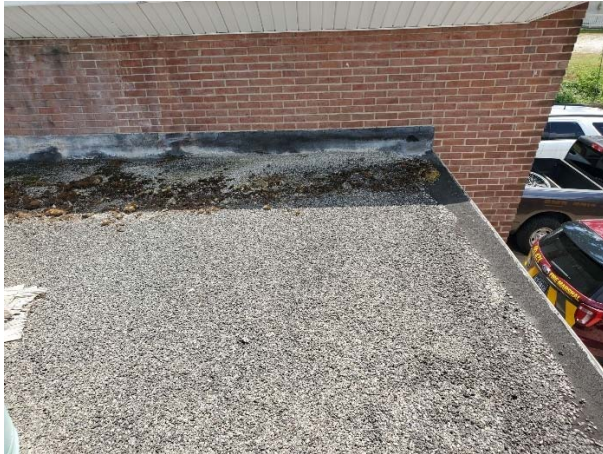
The roof appears to be the original roof to the building. The main level vehicle bay area has tectum decking/ceiling that would need replaced or covered. Water damage is readily apparent in locker area by means of numerous stained and sagging ceiling tiles. Many of the roof penetrations still

appear to have lead flashing which would support the age of the roof being original. This roof is a very low slope that would benefit from additional sloping of the drainage plane based on the structure supporting this change. The existing roof is a modified bitumen with a gravel topping that has been shoveled off in places as required for some repairs. Based on the age of the facility it would be recommended to have the roof tested to see if any hazardous materials made up its composition prior to a replacement of the roofing system. With the decking being tectum, it would be advisable to expect to have to replace at least 10% of the decking while the reroof is performed.

Existing Roofing and Flashing

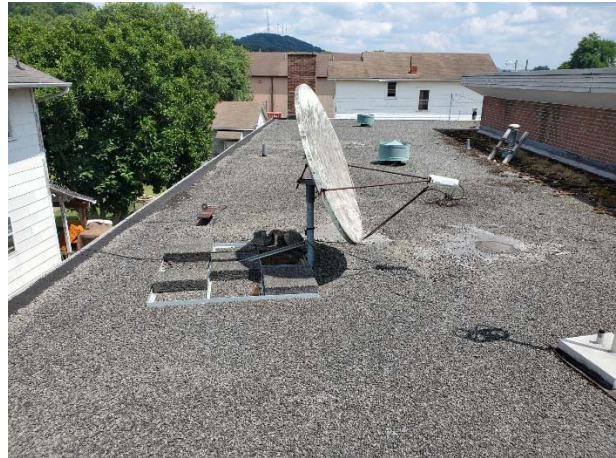
Existing Roofing

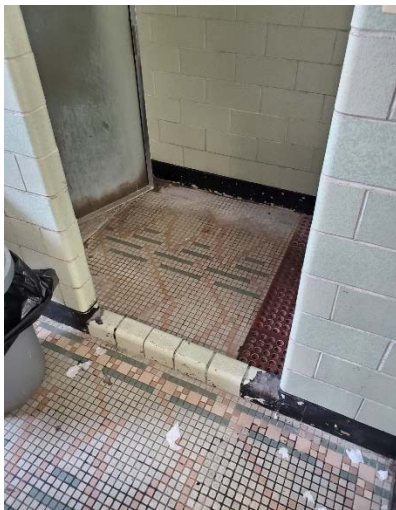
The main-level ADA access is limited due to concrete settling and the raised sidewalk at entrance. The lower-level has restricted ADA access as well, with one door that isn't connected to the lower-level parking. Both levels however have garage doors that are accessible from their respective parking areas. Stairwells are the only means of access between the levels once inside. The interior stairwell has significant water damage. Ink from the face of the batt insulation runs down the walls of the space. If the building is rehabilitated this stairwell would require mold and mildew abatement. None of the restrooms in the building are accessible or ADA compliant. Most of the toilet and shower rooms are small and have built-in curbs to direct the water flow. If the building is rehabilitated the toilet and shower facilities would need to be fully renovated.

Existing Shower

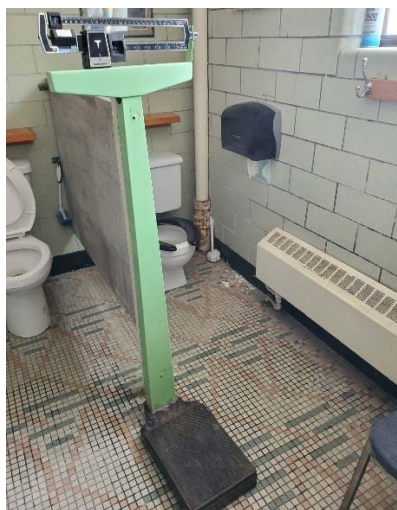
Existing Toilet Stall

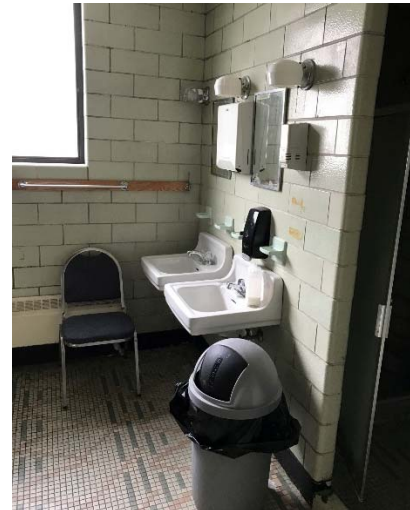
Existing Sinks

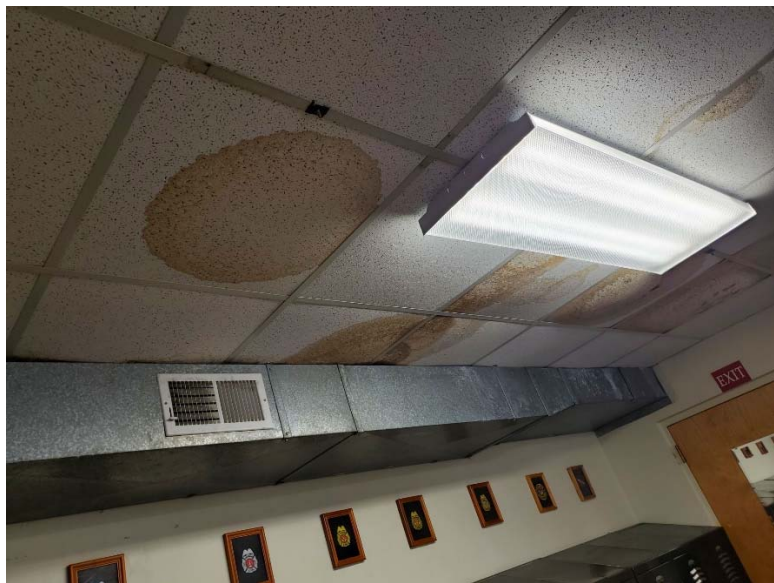
Water Damaged Ceiling Tile

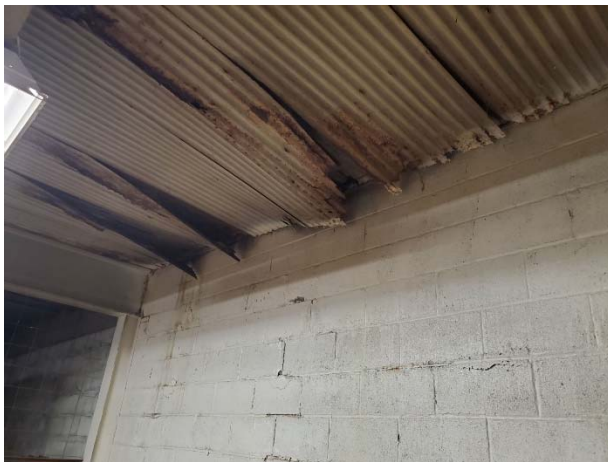
In general, the building appears to be in fair condition from a structural standpoint. Cracks in the masonry were noted throughout, the majority of which are not threatening to the structural integrity of the building. However, there appears to have been a large amount of water intrusion on the front of the building at the two garage bays. This water has caused a large amount of damage to the floor slab between the front wall and the first support beam. As a result, the metal form deck is completely rusted out and the concrete has spalled off the bottom of the slab, exposing the reinforcing bars which are also badly rusted. This area of the slab would need to be cut out and replaced if the building is to be utilized in the future. In addition, the water appears to have been migrating through the block basement wall and has degraded the mortar joints and caused spalling of the block wall. This wall would also need to be repointed and possibly reinforced to maintain the structural integrity of the building in that area. In addition, the source of the water intrusion would need to be investigated and preventative measures taken to avoid future water issues. This may include exposure and waterproofing of the exterior face of the basement wall on the front of the building.

Metal Form Deck and Slab Failure

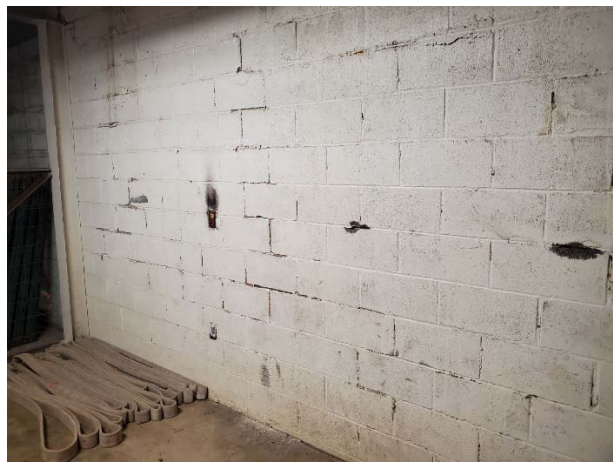
On the lower level of the building masonry cracking is prevalent. The front wall (below the overhead doors) exhibits signs of masonry damage caused by water infiltration. It is noted that temporary structural bracing is in place for this assessment in this area. A permanent structural repair in this area is required. The source of the water damage will need to be corrected from the outside of the building prior to repairing the masonry. Surface rust is apparent on most structural members and most metal objects within the space. As observed from the interior, windows would need replaced from prior damage or removed and replaced with masonry.

Basement Wall Damage

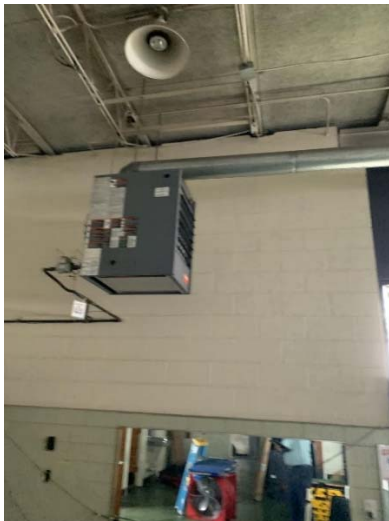
The lower level is provided with heating via a suspended gas fired heater that was installed in 2013. There is no mechanical ventilation air provided for this area.

Suspended Gas Heater

ZMM recommends replacement of the existing heating and air-conditioning systems with a new packaged DX cooling gas heating Roof Top Unit (RTU) sized to provide heating, cooling and ventilation to the entire facility. The RTU would supply cooling and venational air to terminal boxes for individual zone temperature control. The terminal boxes would be provided with heating hot water coils for reheat and variable air flow dampers for space temperature control. A new heating hot water boiler would be provided to serve the VAV terminal boxes. Electric reheat coils may be used in lieu of hot water reheat coils. The recommended HVAC system would provide the most flexibility to the space for various usages.

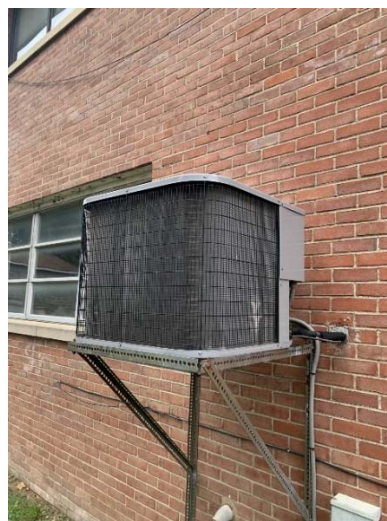
Raised Condensing Unit

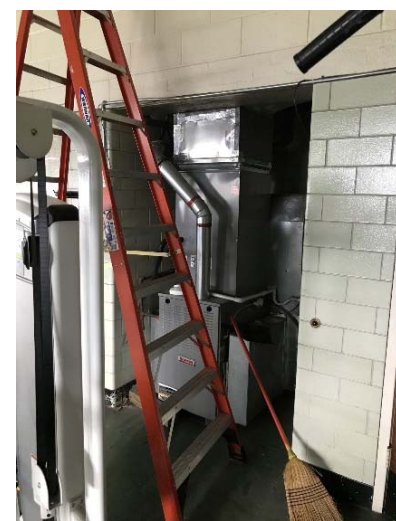
The main level entrance, locker rooms, and cardio area is provided with heating and cooling via a DX split system and gas fired furnace. This system was installed in 2013 and uses 410a refrigerant. This system is controlled by a wall mounted programable thermostat. There is no mechanical ventilation air provided for this area. One office on the main level is provided with cooling via a window type AC unit. There appears to be no heating provided for this space. There is no mechanical ventilation air provided for this area.

Split System Gas Furnace

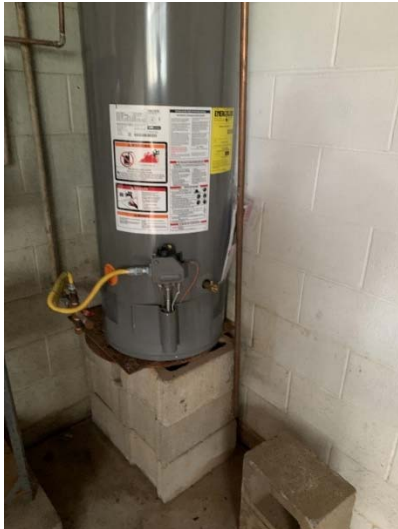
The domestic water is provided by a 1-1/4" service with backflow preventor. The backflow preventor is provided with a drain directly to the outdoors. This can be a path for insects to intern the facility. Domestic hot water is provided by an 80% efficient natural draft gas fired domestic water heater. The heating hot water system does not have an expansion tank. The hot water systems do not have recirculating or mixing valves.

Existing Water Heater

ZMM recommend replacement of the existing manual operated fixtures with new touchless fixtures. ZMM also recommends replacement of the existing 80% efficient gas hot water heater with a new high efficiency direct vent gas domestic water heater. In conjunction with the new water heater, ZMM recommends providing a new domestic hot water recirculation system to both reduce the waste of water and mitigate the risks of legionnaires growth in the system.

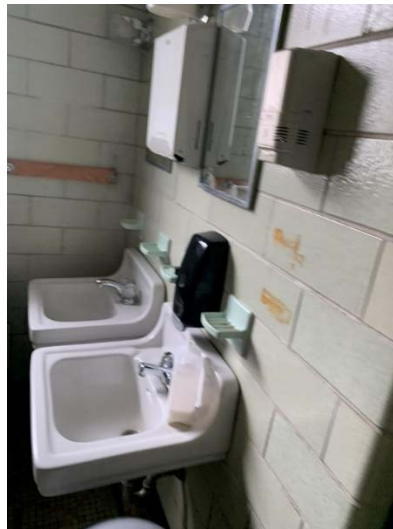
The sanitary and venting systems consist of a mixture of cast iron and PVC piping. The piping appears to be in good/moderate condition. The plumbing fixture are all manual type. The fixtures are not ADA compliant. The water closets are tank type and are standard height. The facility is served by a 1-1/4" low pressure natural gas service. The existing gas piping is in good/moderate condition.

Existing Sinks

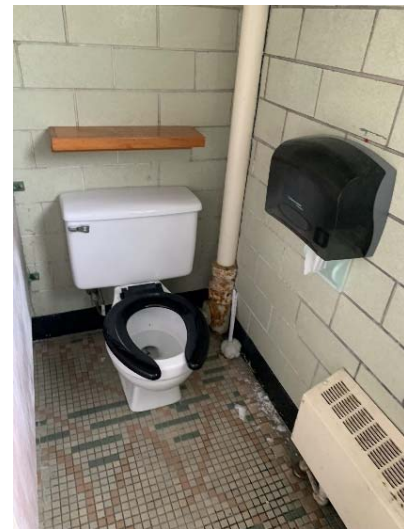
Existing Tank Type Toilet

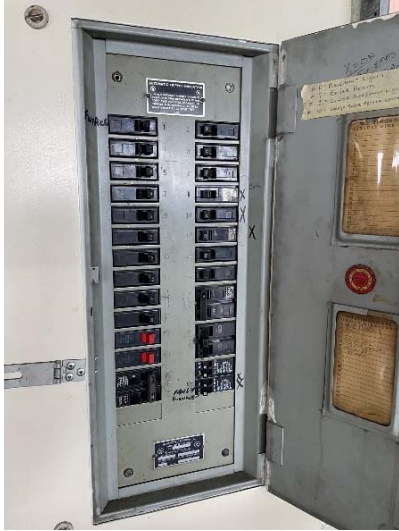
The electrical service for this facility is Single Phase 200 Amp 120/240V. A single Load Center with 30 Poles make up the facility's electrical distribution. The Load Center is original to the building and appears to be close to its max physical capacity. Branch circuiting is a mixture of Metal Clad Cable, Wiring in EMT Conduit, and Non-Metallic Sheathed Cables. Non-Metallic Sheathed cabling is not permitted in commercial buildings per the National Electric Code. Several receptacles around the building are not equipped with a ground wire or plug. There are multiple instances of wires terminated outside of junction boxes or junction boxes with no covers and exposed wiring.

Existing Electrical Panel

ZMM recommends the following electrical upgrades for this building: remove all existing wiring and replace with new per NEC, remove all existing receptacles and replace with new per NEC,

remove all existing lighting (interior and exterior) and replace with LED fixtures, provide lighting controls per latest adopted edition of ASHRAE 90.1, and provide a new hardwired Fire Alarm System per NFPA 101 and the State of West Virginia Fire Code.

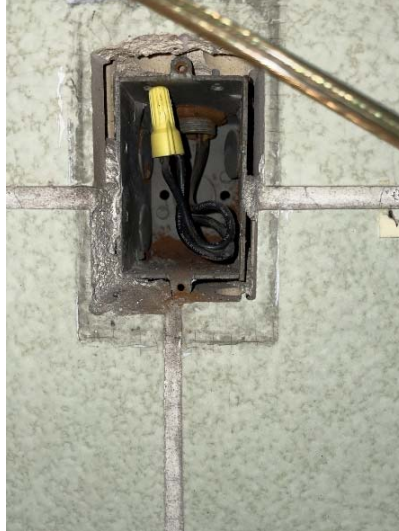
Open Junction Box

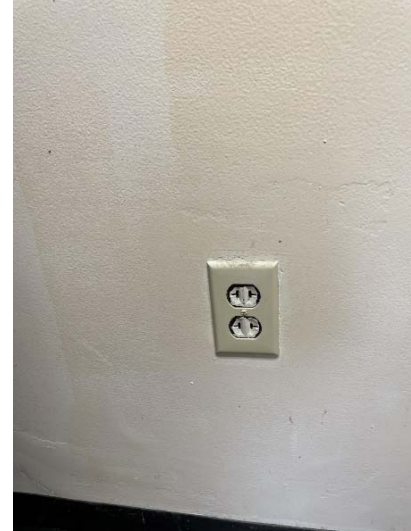
Receptacle (No Ground)

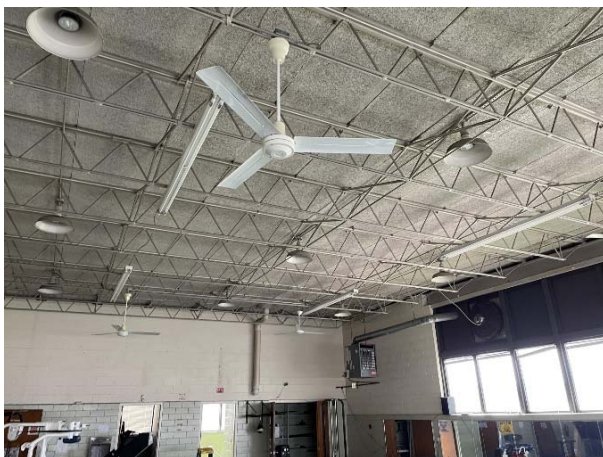
The interior building lighting consists of mainly chain hung fluorescents in the basement, lay-in and surface mounted fluorescents upstairs and HID screw in bulbs in the parking bay area. No occupancy sensors were observed in the building and all lighting controls consists of toggle switching. There did not appear to be any emergency lighting throughout the facility. There were no lighted exit signs, all exit signs observed were painted on or above doorways. Exterior lighting consists of two HID flood lights over the parking bay doors, two LPS bulb type recessed fixtures in main entrance eave and two LPS bulb type wall packs on rear service bay door.

Fitness Area Lighting

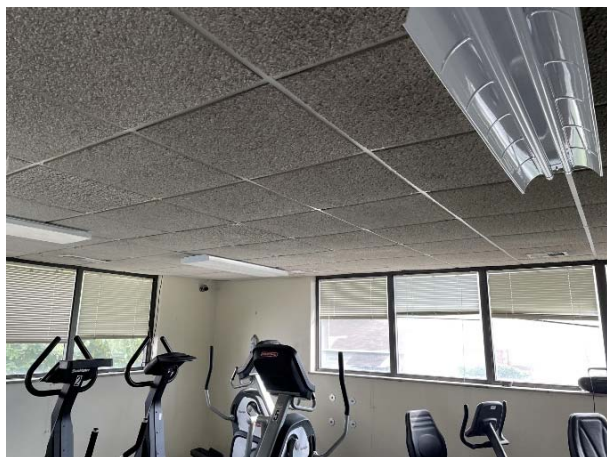
Cardio Area Surface Mounted Lighting
